DEPARTMENT OF TRANSPORTATION

Quality Assurance and Source Inspection

Contract #: 04-0120F4Cty: SF/ALA Rte: 80 PM: 13.2/13.9File #: 69.28**WELDING INSPECTION REPORT****Resident Engineer:**Siegenthaler, Peter**Address:** 333 Burma Road**City:** Oakland, CA 94607**Report No:** WIR-018353**Date Inspected:** 30-Nov-2010**Project Name:** SAS Superstructure**OSM Arrival Time:** 700**Prime Contractor:** American Bridge/Fluor Enterprises, a JV**OSM Departure Time:** 1900**Contractor:** Zhenhua Port Machinery Company, Ltd (ZPMC), Changxing Island **Location:** Shanghai, China**CWI Name:** Mr. Xu Le Feng**CWI Present:** Yes No**Inspected CWI report:** Yes No N/A**Rod Oven in Use:** Yes No N/A**Electrode to specification:** Yes No N/A**Weld Procedures Followed:** Yes No N/A**Qualified Welders:** Yes No N/A**Verified Joint Fit-up:** Yes No N/A**Approved Drawings:** Yes No N/A**Approved WPS:** Yes No N/A**Delayed / Cancelled:** Yes No N/A**Bridge No:** 34-0006**Component:** Tower / OBG**Summary of Items Observed:**

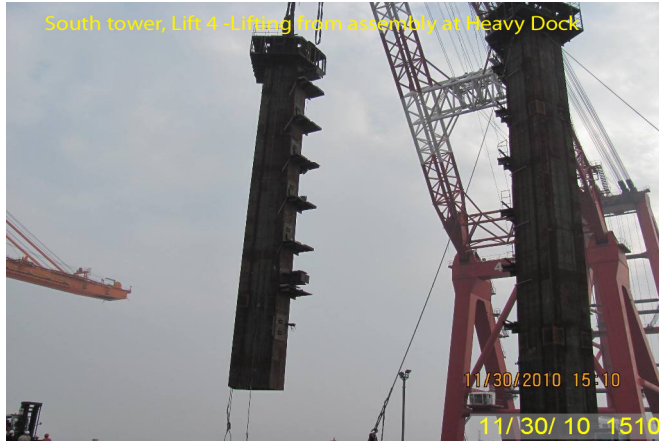
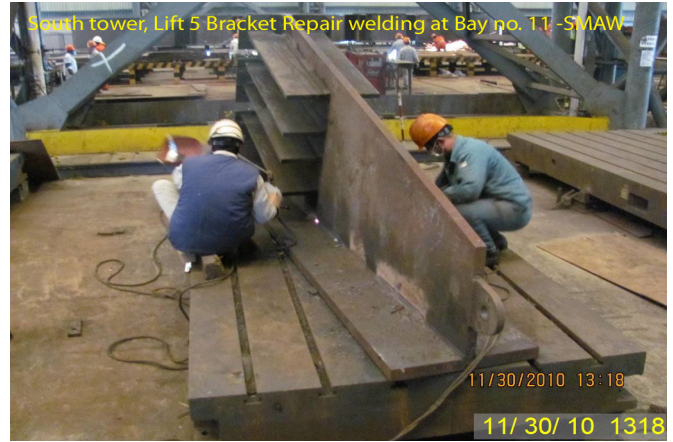
For further information see below pictures:-

Unless otherwise noted, all work observed on this date appeared to be in general compliance with the applicable contract documents.
